| BIL/<br>No | KETERANGAN BARANG DAN<br>PERKHIDMATAN/<br><i>Description of Items and Services</i> | BANYAK/<br>Quantity | HARGA<br>SEUNIT/<br>Price Per<br>Unit | JUMLAH/<br>Total |
|---|---|---|---|---|
| | PROVISION OF SERVICING AND<br>MAINTENANCE FOR THE<br>TELESCOPE INSTRUMENT (ATI<br>UNIT) GEODETIC SECTION,<br>JABATAN UKUR | | | |

ATTACHMENT

# 1. CELESTRON/C8-SGT XLT TELESCOPE (S.200/10/11)

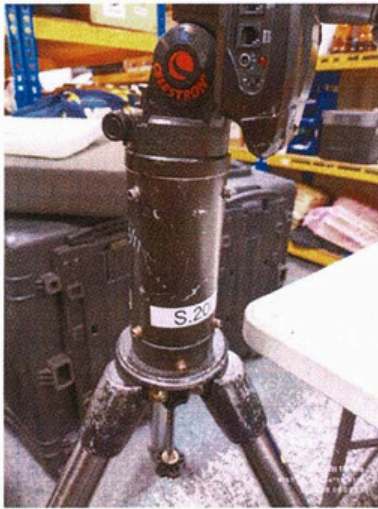
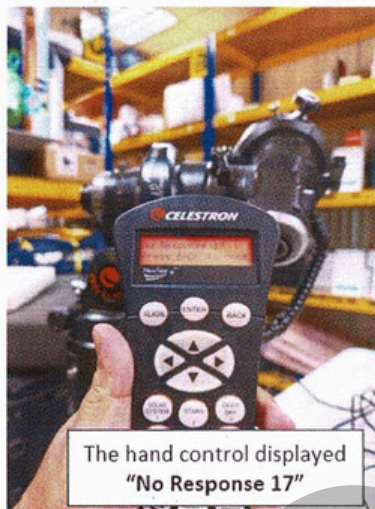
The hand control displayed  
"No Response 17"

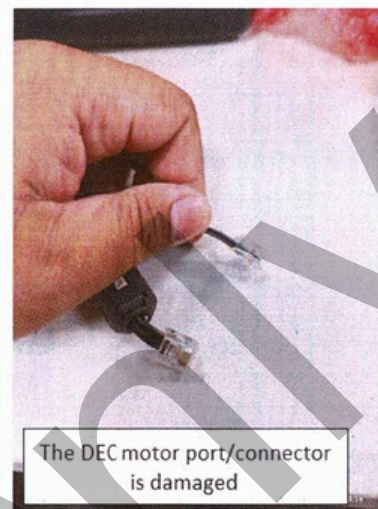
The DEC motor port/connector  
is damaged

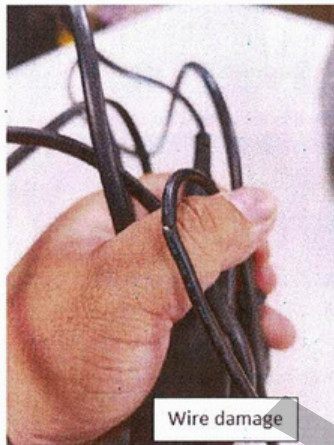
Wire damage

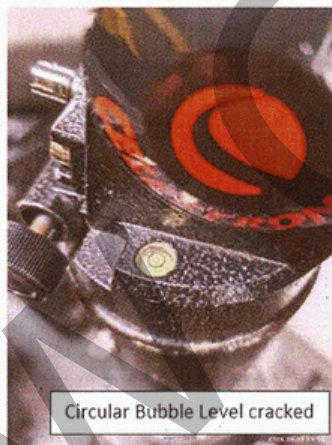
Circular Bubble Level cracked

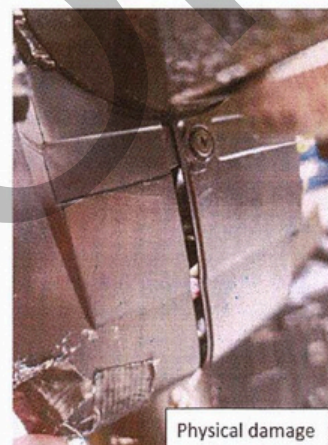
Physical damage

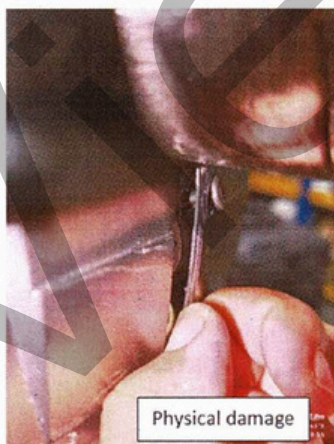
Physical damage

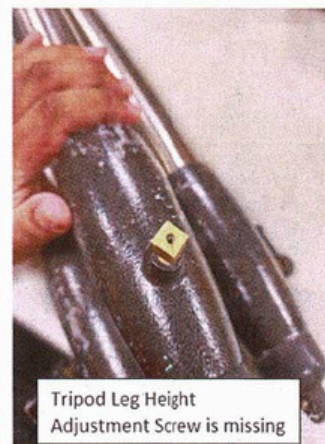
Tripod Leg Height  
Adjustment Screw is missing

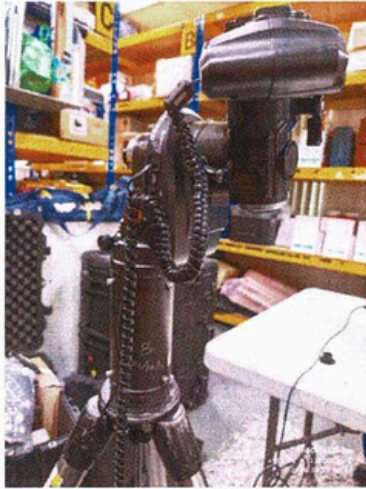
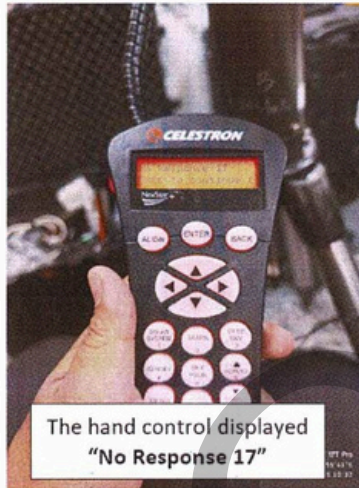
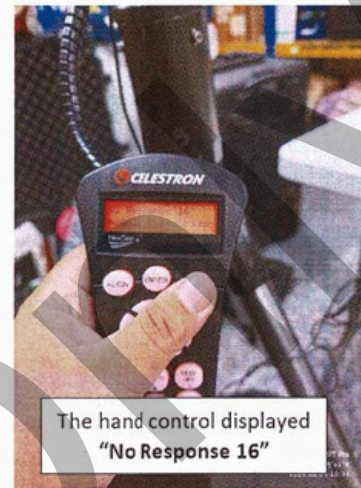
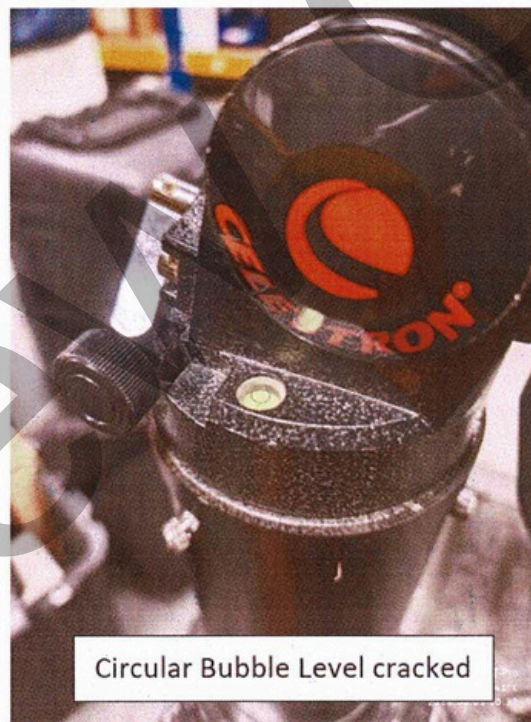
## 2. CELESTRON/C8-SGT XLT TELESCOPE (S.201/10/11)

| 2. | <p><b>CELESTRON/C8-SGT XLT TELESCOPE (S.201/10/11) (1 SET)</b></p> <p><b>PROBLEMS:</b></p> <ul style="list-style-type: none"> <li>• The telescope was subsequently unable to move.</li> <li>• Celestron indicates a "No Response 16" error.</li> <li>• Celestron indicates a "No Response 17" error.</li> <li>• Circular Bubble Level cracked</li> <li>• Physical damage</li> </ul> <p><b>REQUIREMENT :</b></p> <ul style="list-style-type: none"> <li>• Conduct a complete inspection and diagnosis of the telescope.</li> <li>• Identify the root cause of the "No Response 16 / No Response 17" errors.</li> <li>• Check the RA and DEC motor systems.</li> <li>• Check the DEC port, connectors and cables.</li> <li>• Check the motor control board.</li> <li>• Check the mechanical condition of the mount and gear system.</li> <li>• Repair or replace defective components where necessary.</li> <li>• Ensure all replacement parts are compatible with the Celestron C8-SGT XLT.</li> <li>• Carry out functional testing after servicing.</li> <li>• Ensure that the telescope can perform RA and DEC slewing correctly.</li> <li>• Ensure the telescope can stop slewing normally through the hand control.</li> <li>• Conduct final testing and calibration before returning the instrument to Jabatan Ukur.</li> <li>• Focusing Screw requires rethread</li> <li>• Full Cleaning Service</li> </ul> <p>[Kindly see attachment for Detail]</p> | 1 LOT | | |

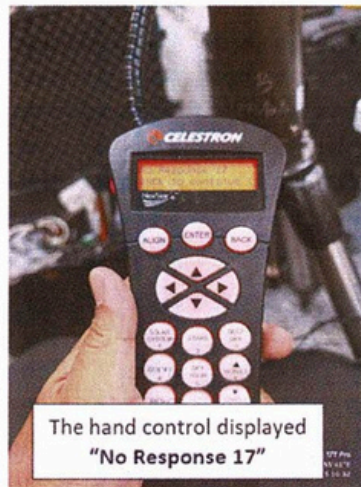
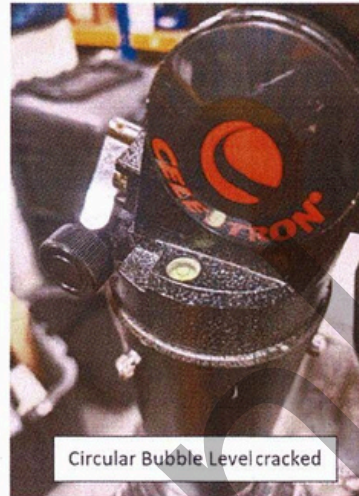
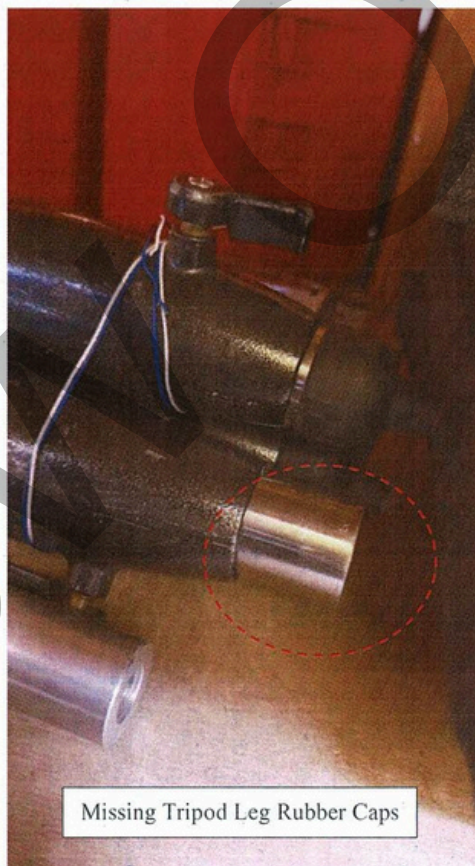
### 3. CELESTRON/C8-SGT XLT TELESCOPE (S.202/10/11)

| <p><b>3.</b></p> | <p><b>CELESTRON/C8-SGT XLT<br/>TELESCOPE (S.202/10/11)<br/>(1 SET)</b></p> <p><b>PROBLEMS:</b></p> <ul style="list-style-type: none"> <li>• Celestron indicates a "No Response 17" error.</li> <li>• The telescope does not stop slewing.</li> <li>• Circular Bubble Level cracked</li> <li>• Physical damage</li> </ul> <p><b>REQUIREMENT :</b></p> <ul style="list-style-type: none"> <li>• Conduct a complete inspection and diagnosis of the telescope.</li> <li>• Identify the root cause of the "No Response 16 / No Response 17" errors.</li> <li>• Check the RA and DEC motor systems.</li> <li>• Check the DEC port, connectors and cables.</li> <li>• Check the motor control board.</li> <li>• Check the mechanical condition of the mount and gear system.</li> <li>• Repair or replace defective components where necessary.</li> <li>• Ensure all replacement parts are compatible with the Celestron C8-SGT XLT.</li> <li>• Carry out functional testing after servicing.</li> <li>• Ensure that the telescope can perform RA and DEC slewing correctly.</li> <li>• Ensure the telescope can stop slewing normally through the hand control.</li> <li>• Conduct final testing and calibration before returning the instrument to Jabatan Ukur.</li> <li>• Focusing Screw requires rethread</li> <li>• Full Cleaning Service</li> </ul> <p><b>[Kindly see attachment for Detail]</b></p> | <p>1 LOT</p> | | |
